# Analysis of the Influence of Second-Order Excitation in the Transmission System on Acceleration Vibration

Enfu Niu<sup>\*</sup> and Jian Mao

Changan Kaicheng Vehicle R&D Centre, Dingzhou City Hebei Province China.

Date of publication (dd/mm/yyyy): 03/06/2023

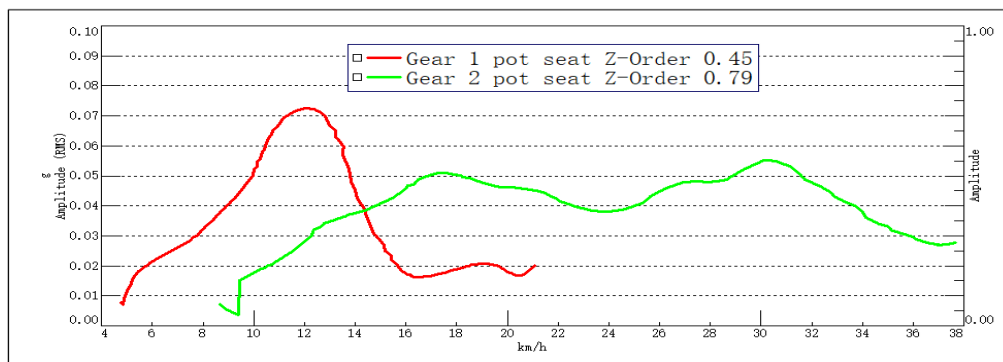
Fig. 1. 1st and 2nd gear pot seat vibration.

The vibration amplitude of the first gear is as high as 0.072g, as shown in Figure 1. The order characteristics of the whole vehicle vibration problem correspond to the second order of the transmission system, so it is first suspected that the vibration problem is caused by the transmission system.

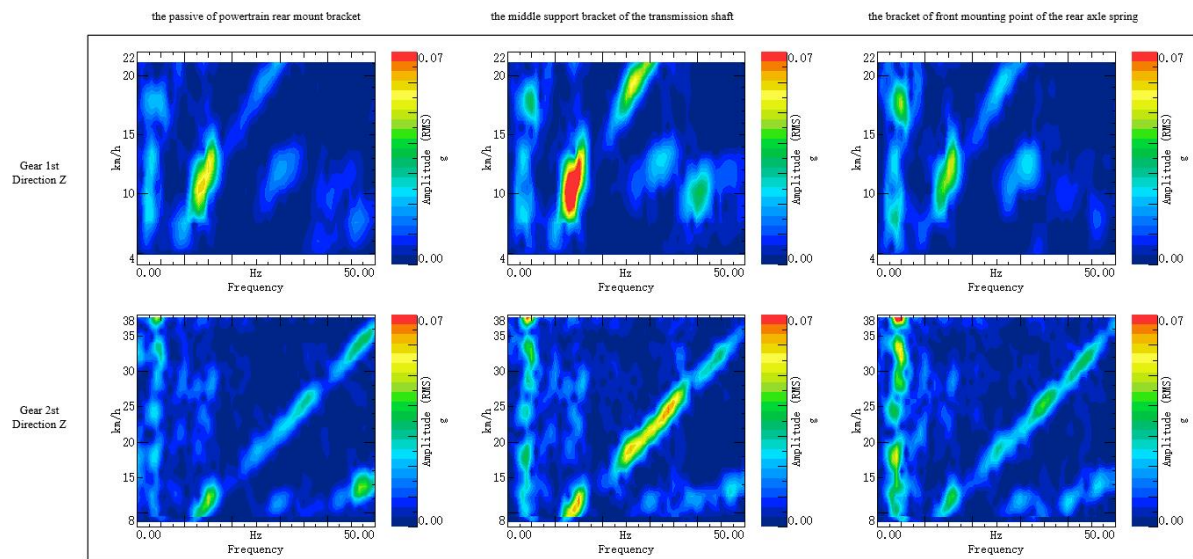
Fig. 3. Vehicle speed characteristics of vibration at each measuring point.

The test conditions are 1st and 2nd gear pot conditions, and the vehicle speed characteristics and order characteristics of the vibration at each measuring point are shown in Figure 3 and Figure 4.

The experimental results show that the positions with the highest vibration response in the first and second gear working conditions are all middle support bracket of transmission shaft, with orders of 0.45 and 0.79, respectively, corresponding to the second-order excitation of the transmission system. This indicates that the excitation source of this vibration problem is the second-order excitation of the transmission system.

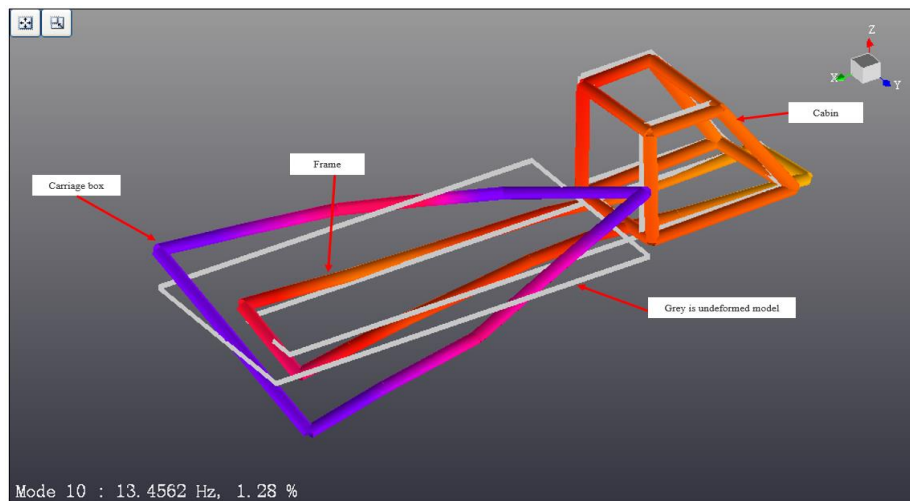
Fig. 5. First order torsional mode of frame.

vehicle is 13.5Hz, as shown in Figure 5. The rigid body modal frequency of the middle support of the transmission shaft is 28.3Hz, with a damping ratio of 5.34%. The main peak energy of the IPI at the origin of the middle support is 24-32Hz, as shown in Figure 6. By comparing the vibration response characteristics of each measurement point of the entire vehicle and the modal test results of each system, it can be determined that the vibration mechanism is the resonance caused by the middle support modal and the first order torsional mode of the entire vehicle being excited by the second order excitation energy of the transmission system, resulting in the vibration of the entire vehicle.

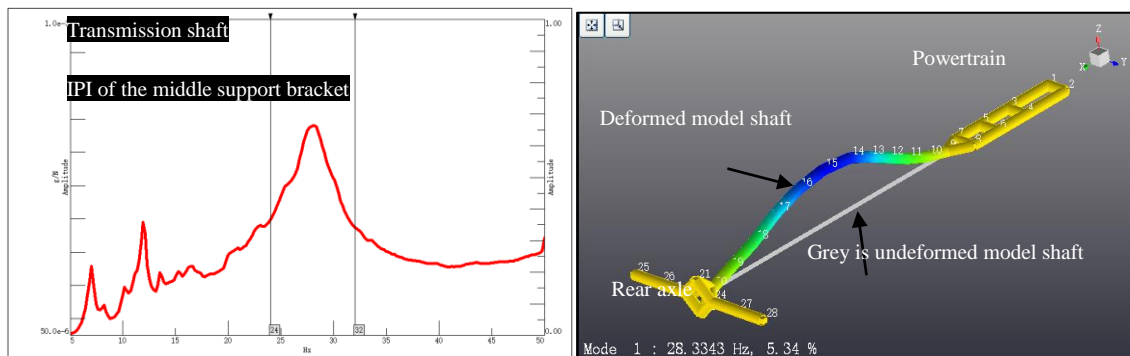
Fig. 6. IPI of middle support bracket and rigid modal of transmission shaft.

From the above transmission path analysis, it can be seen that the mechanism of causing vehicle body vibration at 5-30 km/h is that the second-order excitation energy of the transmission system generates strong low-frequency resonance between the middle support and the body. Due to the fact that the modal frequencies of the middle support rigid body and the first order torsion of the vehicle body meet the design specifications, and the high cost of adjustment in the later stage of vehicle development, the optimization control strategy adopted in this paper is to reduce the excitation energy of the excitation source.

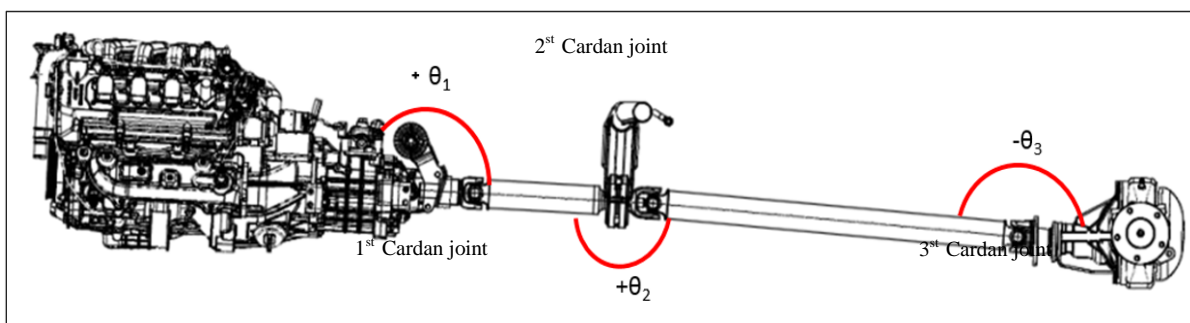
Fig. 8. Transmission system layout plan.

The transmission system layout scheme of the real vehicle is shown in Figure 8. The first to the third universal joints are vertical, vertical and horizontal respectively. According to the calculation formula of the equivalent included angle of the transmission system, the first and second universal joint take positive value, and the third universal joint takes negative value.

After calculation, the equivalent angle of the actual vehicle is  $6.08^\circ$ , which is much greater than the design value of  $0.71^\circ$ , especially the first angle  $\theta_1$  and the second angle  $\theta_2$ . There is a significant deviation from the design value.

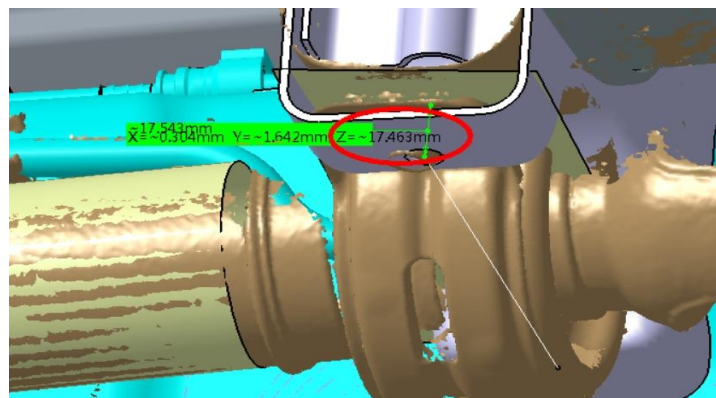
Fig. 9. Comparison between the actual vehicle and design state of the middle support.

After comparing the differences between the three-coordinate scanning data of the actual vehicle and the design data, as shown in Figure 9, it was found that the bottom surface of the middle support bracket (yellow) of the actual vehicle is 17.46mm higher than the bottom surface of the design state (gray), which is the reason for the excessive equivalent angle of the transmission system.

To quickly determine the cause of the vibration, an 18mm shim was added at the position of the connecting bolt between the middle support and the transmission shaft to reduce the height of the middle support and bring it closer to the design angle of the transmission system. At this time, the equivalent angle is  $1.5^\circ$  (meeting the requirement of less than  $3^\circ$ ), as shown in Table 3.

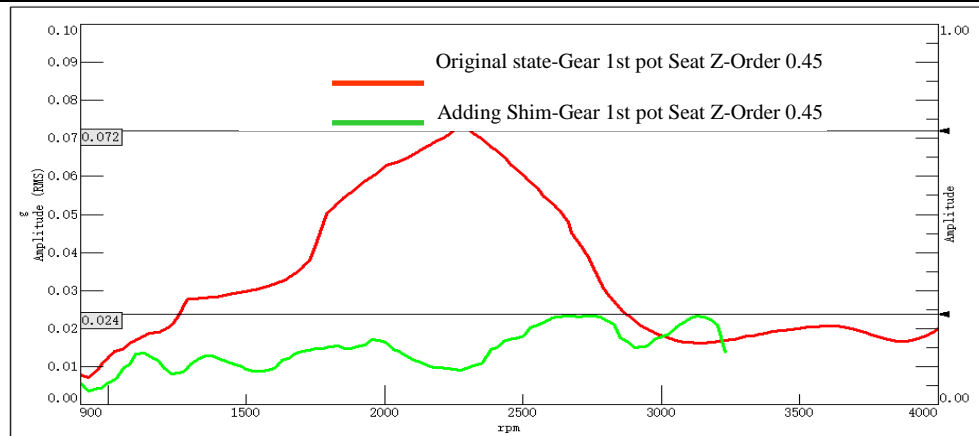
Fig. 10. Effect of manual solution.

The measured maximum value of seat vibration decreased from 0.072g to 0.024g, as shown in Figure 10, and the subjective evaluation of vibration completely disappeared. At this point, it can be confirmed that the cause of the vibration of this vehicle is due to the deviation of the middle support position, which leads to the deviation of the equivalent angle of the transmission system, resulting in a larger second-order excitation of the transmission system.

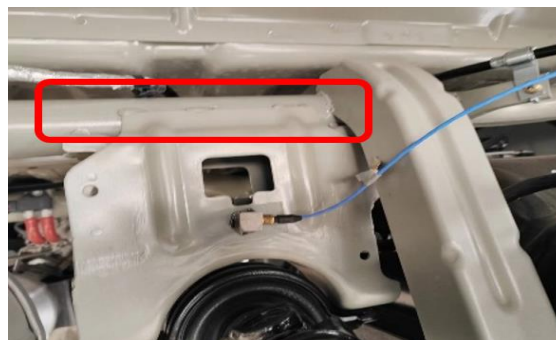
Fig. 11. Welding status of the middle support of the transmission shaft and the pipe beam.

A detailed traceability investigation was conducted on the middle support bracket, and it was found that the middle support bracket and the bracket tube beam were welded, as shown in Figure 11. The welding between the bracket and the pipe beam is significantly out of tolerance, with a measured value of 17.46mm (standard  $\pm 2$ mm). Therefore, it is confirmed that the vibration problem of this vehicle is caused by the unqualified manufacturing of components, resulting in the vibration problem. It is necessary to strictly control the welding accuracy of the middle support in the later stage to ensure that the equivalent angle of the transmission system meets the design requirements, in order to avoid the vehicle vibration problem caused by the large second-order excitation of the transmission system.
