# Analysis of the Influence of Second-Order Excitation in the Transmission System on Acceleration Vibration

Enfu Niu<sup>\*</sup> and Jian Mao

Changan Kaicheng Vehicle R&D Centre, Dingzhou City Hebei Province China.

Date of publication (dd/mm/yyyy): 03/06/2023

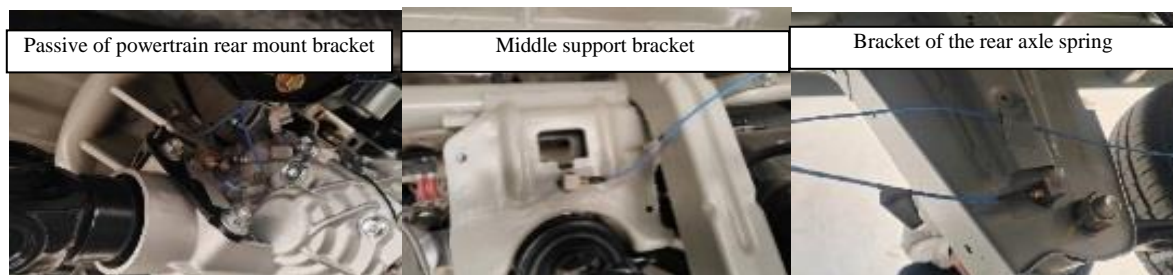
Fig. 2. Location of Sensor Measurement Points.

Due to the fact that the vibration problem is related to vehicle speed, in order to extract the signal characteristics of the whole vehicle vibration, three axis acceleration sensor is arranged on the passive of powertrain rear mount bracket, the middle support bracket of the transmission shaft, and the bracket of front mounting point of the rear axle spring, as shown in Figure 2.

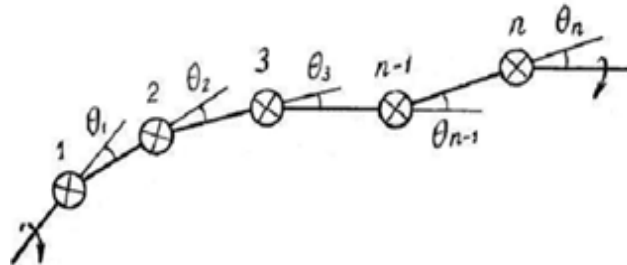
Fig. 7. Schematic diagram of transmission shaft arrangement angle.

As shown in Figure 7,  $\theta_1, \theta_2, \theta_3, \dots, \theta_n$  are the angle between the input and output shafts of each universal joint of the transmission shaft. The calculation formula for the equivalent angle of the transmission shaft is as follows:
