# Ni-Co Alloys for Steam Turbine Blade Restoration by Welding Application

**Abstract** – Ni-Co alloys boron doped were fabricated by induction melting technique. The deposition of the alloys with and without boron was applied by using the TIG welding method (tungsten inert gas). Microstructure analyses of the deposited alloys in the cross-section were performed under SEM techniques. Interface displayed directionally solidified fine equiaxed grains, while columnar grains were observed in the filler with some diffusion degree inner the metal base superior zone. Tension tests have shown that welded samples Ni-Co boron doped present improved resistance, moreover, the samples present good cohesion at the interphase since the fracture occurs in filler material. Numerical analyses were performed and zones of maximum stresses and strains can be detected. These modeling results support with high approximation degree the experimental analyses.

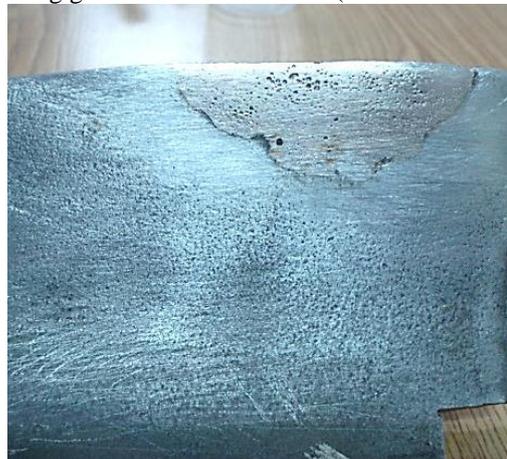
A gas turbine blade was repaired by using TIG (Tungsten Inert Gas) welding method, as is showed in Fig. 1, with a 0.317 cm diameter Thoried electrode (2%) at 125 A, travel speed of 5cm per minute, beam angle of  $30^\circ$  and a shielding gas of 25% He-75 % Ar (flux of 5 ml/min.)

Fig.1. Alloy deposition of a sectioned turbine blade by TIG welding before finishing process.
